Continued appraisal of domestic CO alarms

Prepared by **Advantica Technologies Ltd** for
the Health and Safety Executive 2003

RESEARCH REPORT 165

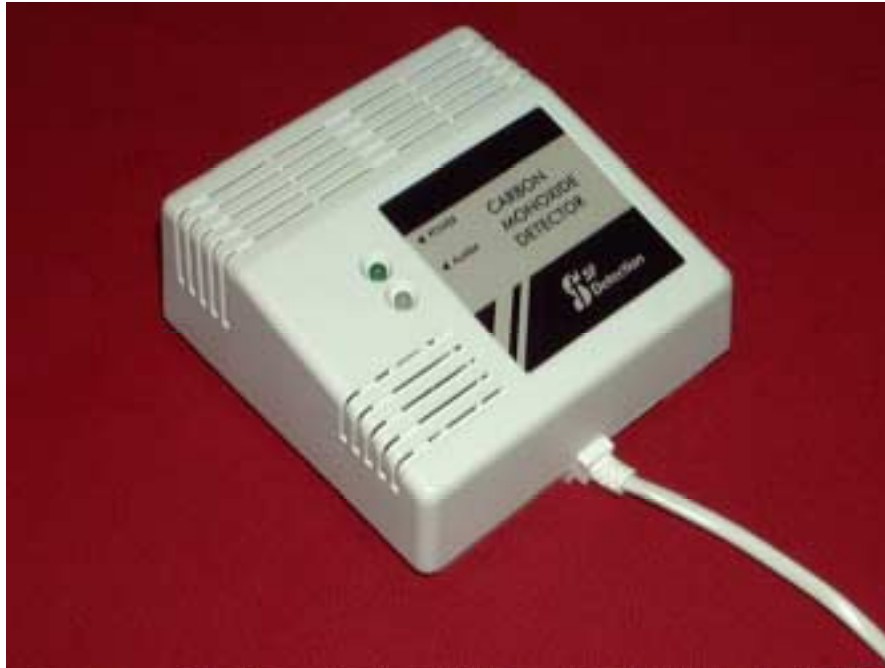
Figure 1. SF310 Domestic CO Alarm

Comparisons have previously been made with an earlier generation of domestic CO alarm, epitomised by the SF310 (Figure 1) manufactured by SF Detection Ltd. Although no longer in production, this unit is considered to be representative of a range of similar models utilising the Figaro TGS203 semiconductor sensor, which was effectively the industry “norm” in the early 1990s. Note that the SF310 was not designed to conform to the performance requirements of BS 7860, although it incorporated many of the features later adopted by that standard. Results of more recent assessments, roughly in chronological order, are summarised as follows:

- SF310: As described earlier, this unit is representative of older designs, and Figure 15 shows results for specimens that have been on trial since before the start of the present programme. It can be seen that the alarm performance has been reasonably stable over that time, but note that the unit was never intended to comply with the requirements of BS 7860. Hence, the initial calibration settings would have been less onerous, which may have contributed to an improved reliability.

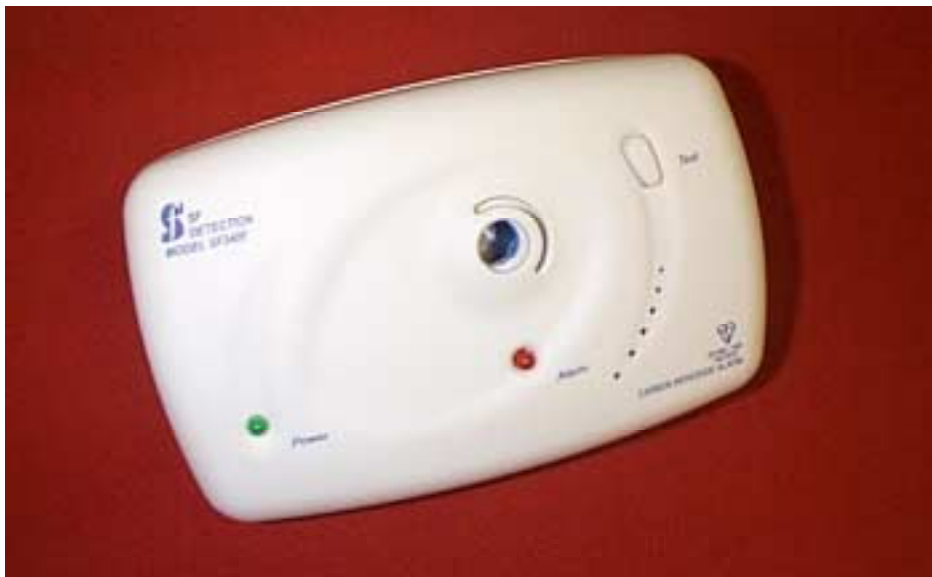
Figure 2. SF340 Domestic CO Alarm

- a) SF340E (see Figure 2). This unit is mains powered with 9-volt battery backup, and incorporates the SF Detection Ltd MIDI 40 electrochemical cell. Performance did not conform to BS 7860 requirements, in that alarm calibrations on some units were not sufficiently sensitive. In addition, the sensor module did not appear to fit correctly within the locating clips on some units, so that the top cover would not close fully.

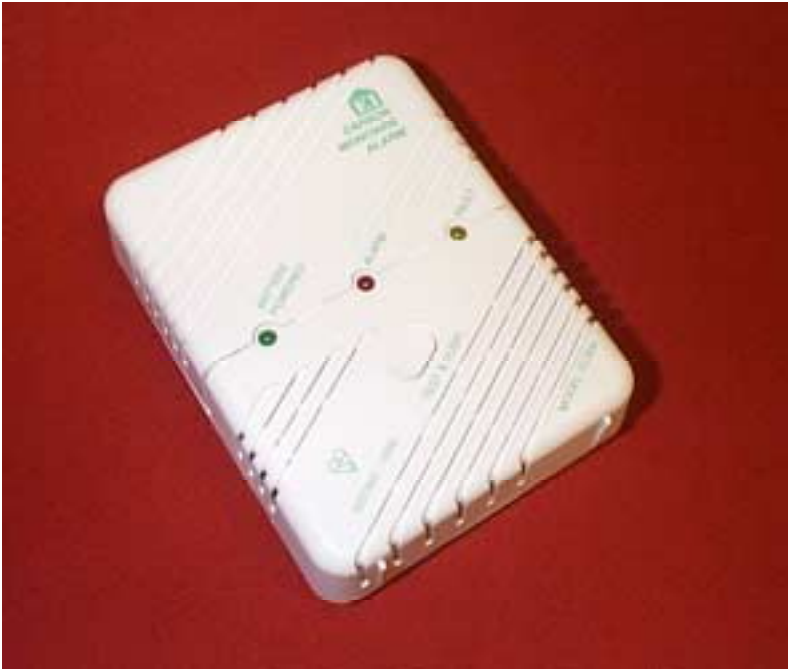
Figure 3. EI 204/205 Domestic CO Alarm

- c) EI 204/5 (see Figure 3). Visually very similar to the EI 225, these two models are powered by three 1.5-volt batteries and utilise the same electrochemical sensor as the SF330KM. They are kite-marked to BS 7860, and initial tests indicated satisfactory alarm performance.

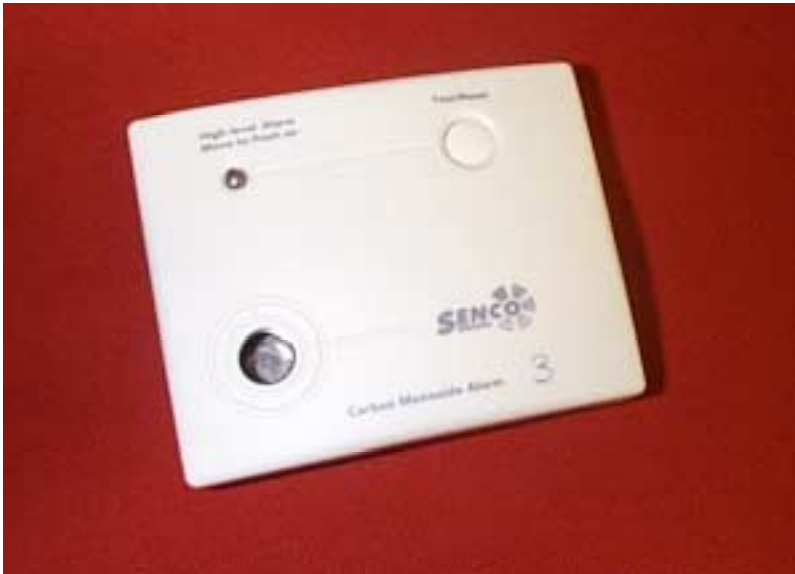
Figure 4. Senco 2002/2003 Domestic CO Alarm

- d) Senco 2001/2/3. The original Senco model ONE (described in Reference 1) has now been re-named the model 2001. Two alternative models have also been introduced (Figure 4) based on the same electrochemical sensing technology with 9-volt battery, but without the digital display. Samples of both the 2002 and 2003 performed well in initial tests.

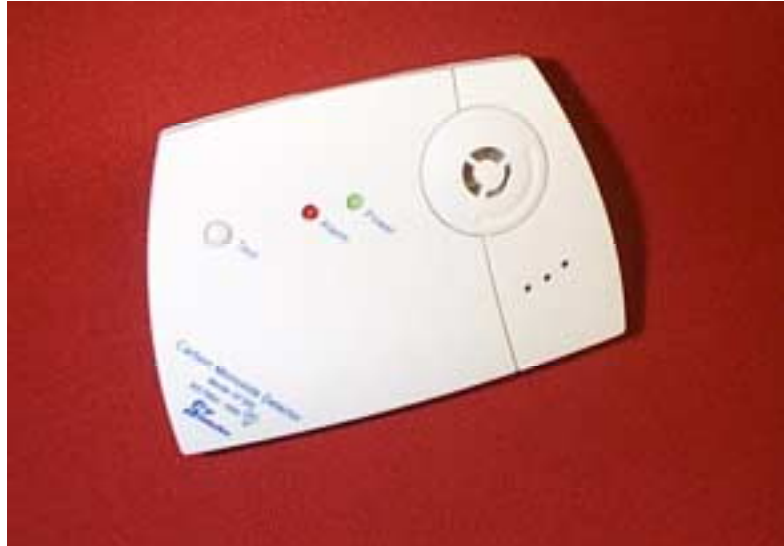
Figure 5. SF350 Domestic CO Alarm

- e) SF350 (Figure 5). This unit has a non-replaceable 9-volt battery and is kite-marked to BS 7860. It uses the proprietary MIDI 40 electrochemical sensor and, when tested, performance was found to be entirely satisfactory.

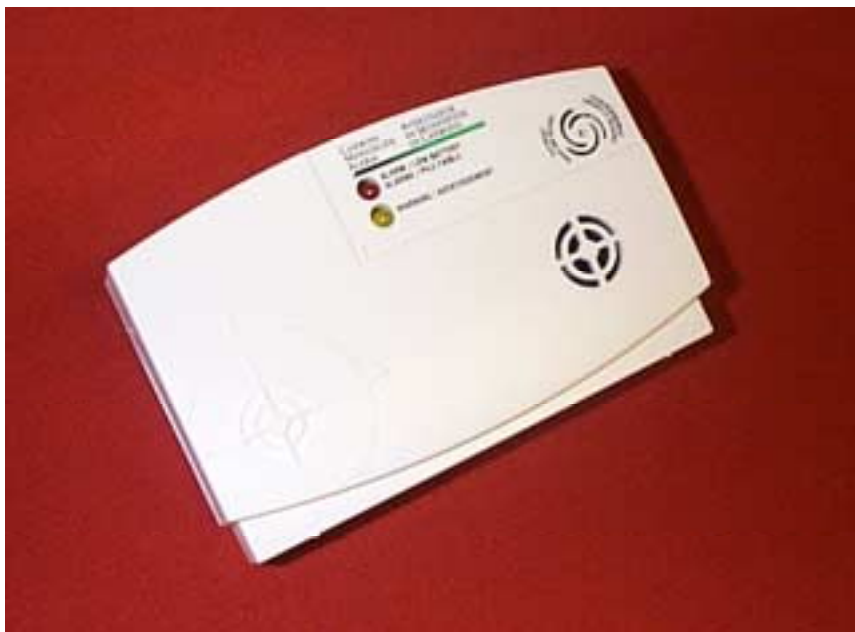
Figure 6. Dicon CO1100 Domestic CO Alarm

- f) Dicon CO1100 (Figure 6). Powered by a replaceable 9-volt battery, it uses the Quantum reagent gel (sometimes called colourimetric or biomimetic) sensor. No compliance with BS 7860 is claimed, although performance was found to be reasonably close when tested. It was noted that alarm recovery times increased at low ambient temperatures.

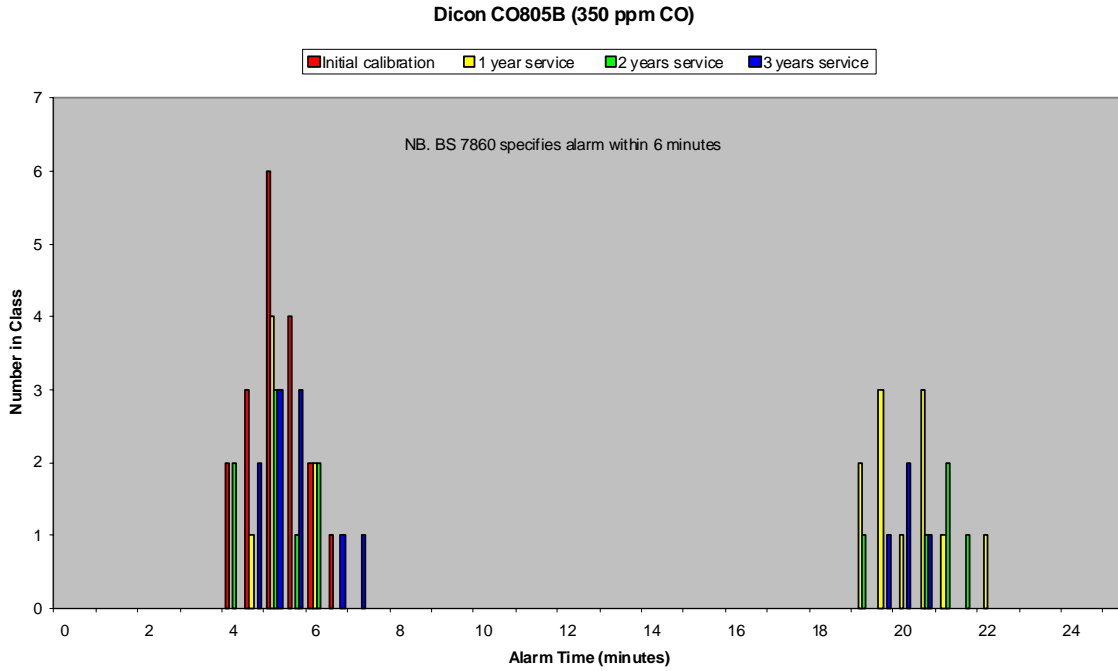
Figure 7. Dicon CO805B Field Trial Results

- CO805B: Units have now been on trial for three years, and results for the field trial specimens are shown in Figure 7. This model was originally selected partly because it utilised a sensor for which long-term data were not readily available. It can be seen that significant variations have occurred in sensor performance, making it very difficult to predict the likely behaviour in future. Six out of the original twenty have now been withdrawn from the trial, mainly due to excessive loss of sensor sensitivity. The manufacturer has indicated that this model was not a commercial success, and only small numbers were sold.
- CO1100: A small number of units have been on trial for six months so far, and performance is shown in Figure 8. As stated earlier, this model has only recently been introduced and is not approved to BS 7860, but behaviour nevertheless looks promising.

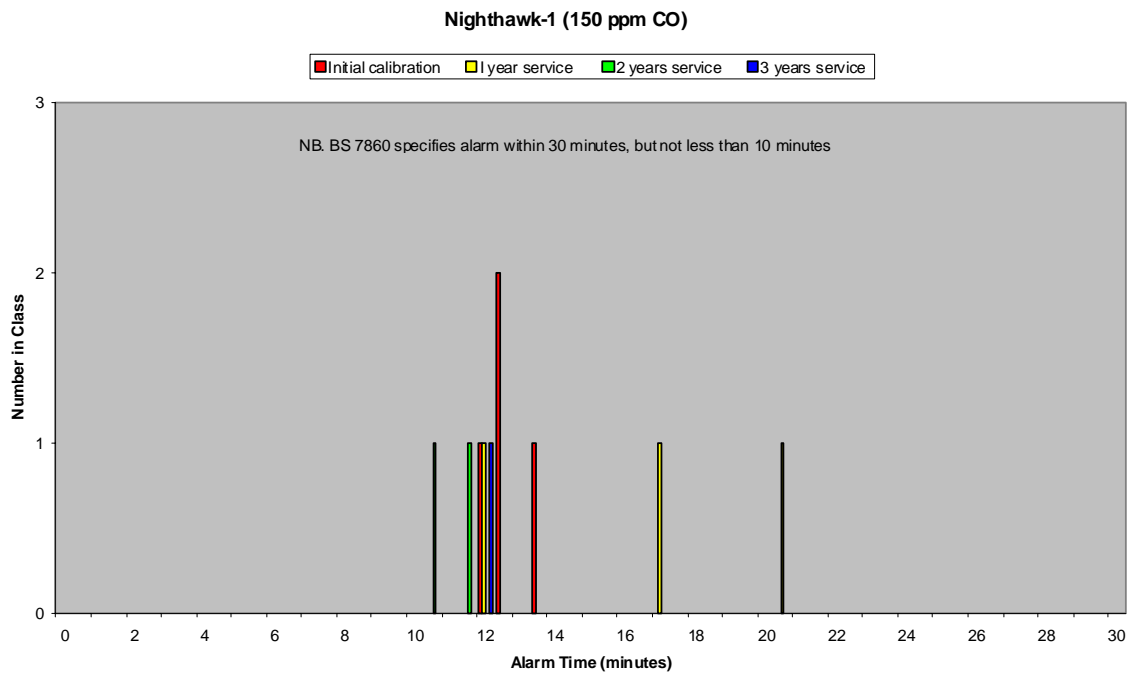
Figure 9. Kidde Nighthawk-1 Field Trial Results

- Nighthawk-1: As with the EI 225, this model uses the same long-established sensing technology as the SF310. The small sample of field trial units has now completed three years in service, and it can be seen from Figure 9 that performance is becoming increasingly variable. Note that, whilst Nighthawk models with this type of sensor are no longer manufactured, later variations cannot easily be distinguished except by reference to the production date code. As a rough guide, this first version was dated 1998.

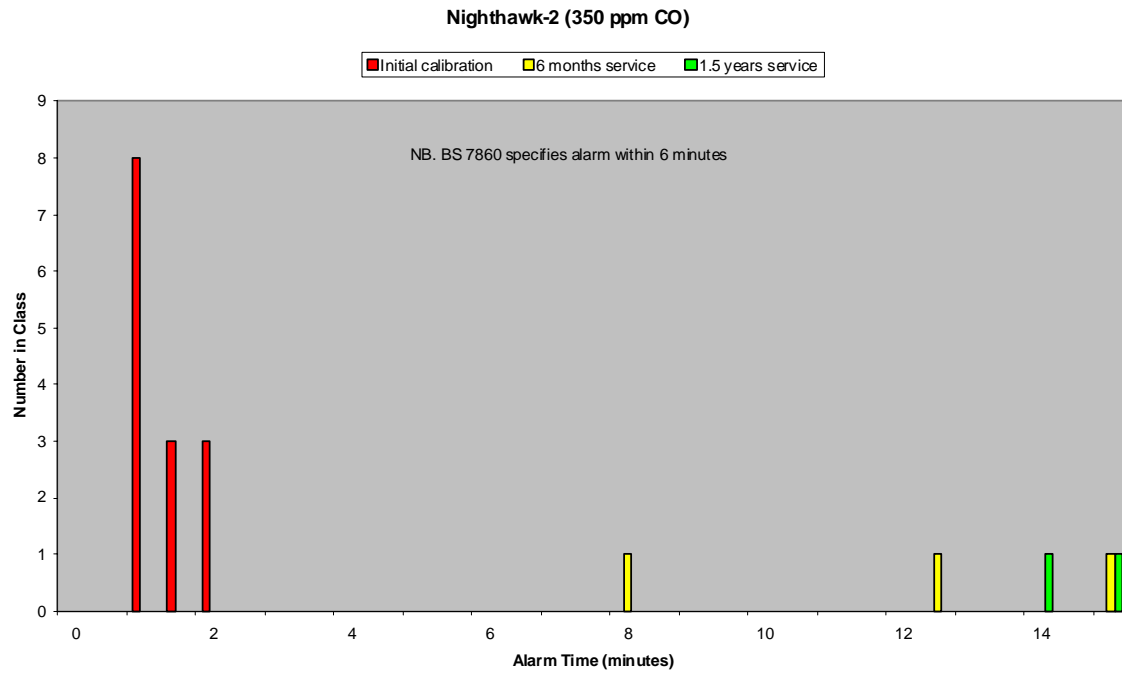
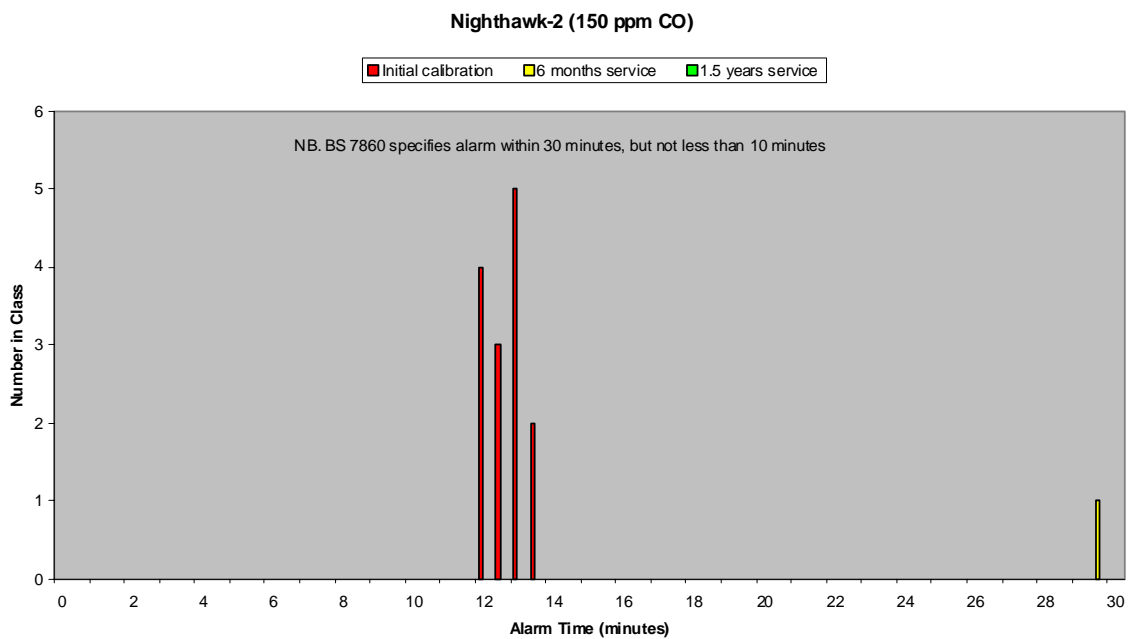
Figure 10. Kidde Nighthawk-2 Field Trial Results

- Nighthawk-2: Date-coded 1999, this version (described in detail in Reference 1) was withdrawn from field trial after 18 months, due to an excessive decrease in sensitivity of the proprietary electrochemical sensor (see Figure 10). Production was halted at about the same time, together with a product recall in the USA.

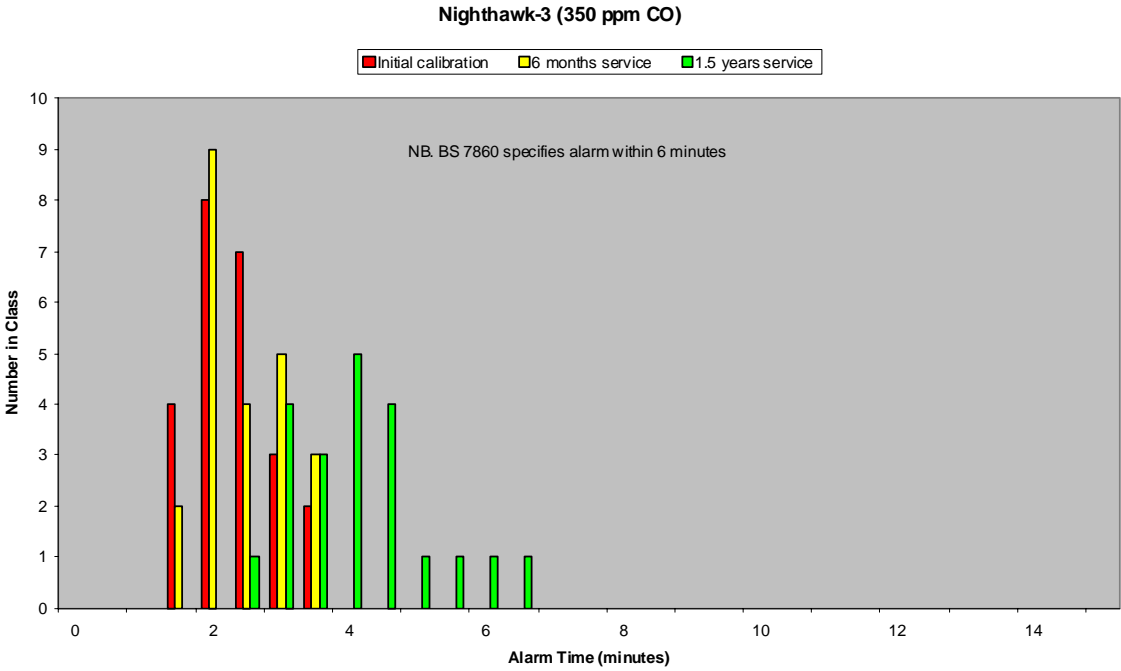
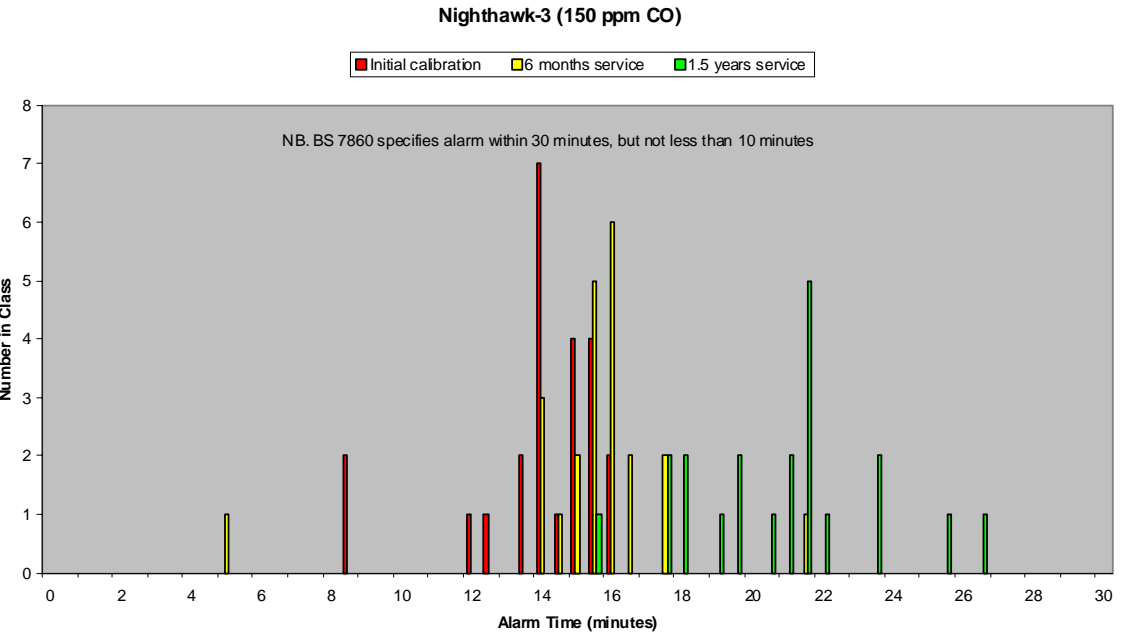
Figure 11. Kidde Nighthawk-3 Field Trial Results

- Nighthawk-3: This version (production date-coded 2000) included a charcoal filter on the sensor. Samples have now been on field trial for 18 months, and Figure 11 shows that performance is satisfactory so far, with only small changes evident. However, it should be noted that low temperatures appear to cause an increase in sensitivity for some units, and that reports have been received of sporadic “fault” alarms for no apparent reason. One unit has failed completely, possibly due to a faulty power transformer, as occurred on an earlier version. The manufacturer has indicated that market figures are in the process of being collated, together with other suppliers, through the Council of Gas Detection and Environmental Monitoring. Numbers in service are likely to be significant, however, as they are retailed through major DIY chains.

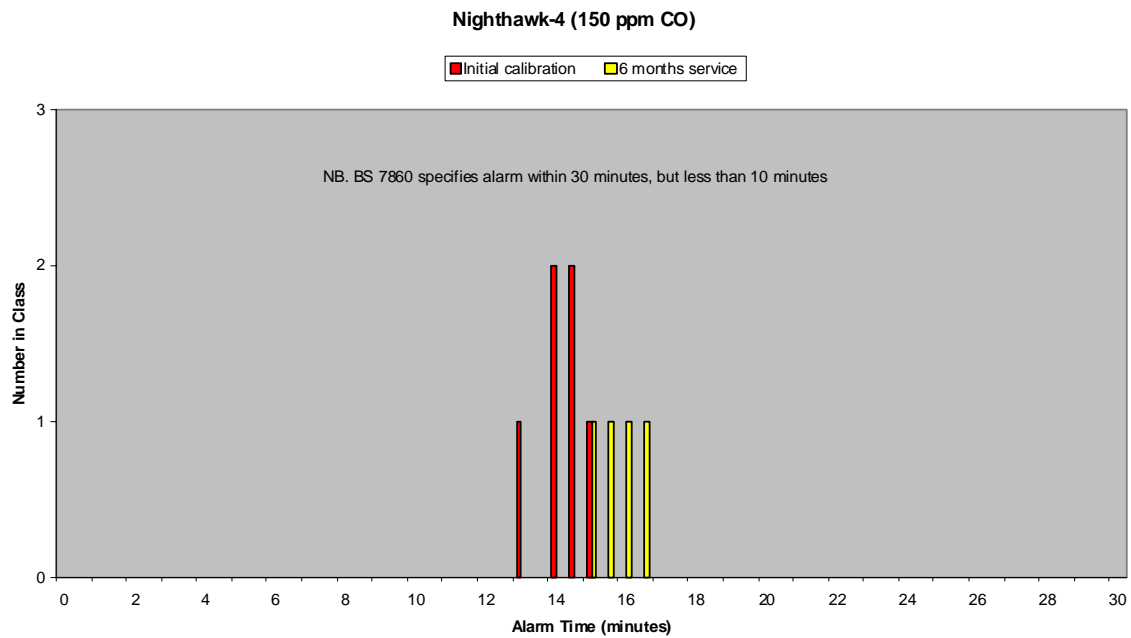
Figure 12. Kidde Nighthawk-4 Field Trial Results

- Nighthawk-4: The most recent version (production date-coded 2001) used a slightly different sensor design, intended to improve stability. Figure 12 shows performance of a small batch over six months and, although four are satisfactory, one has been withdrawn due to a faulty buzzer, and another has been withdrawn because of an excessive decrease in sensor sensitivity. The manufacturer is considering these findings, which conflict with their own long-term data.

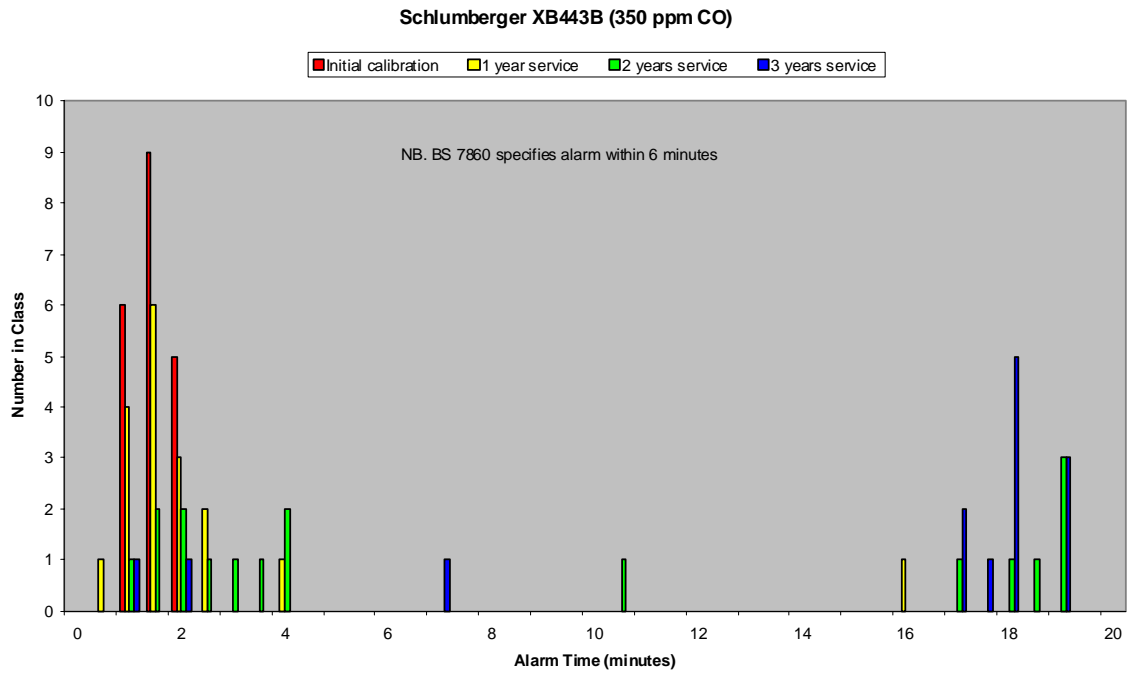
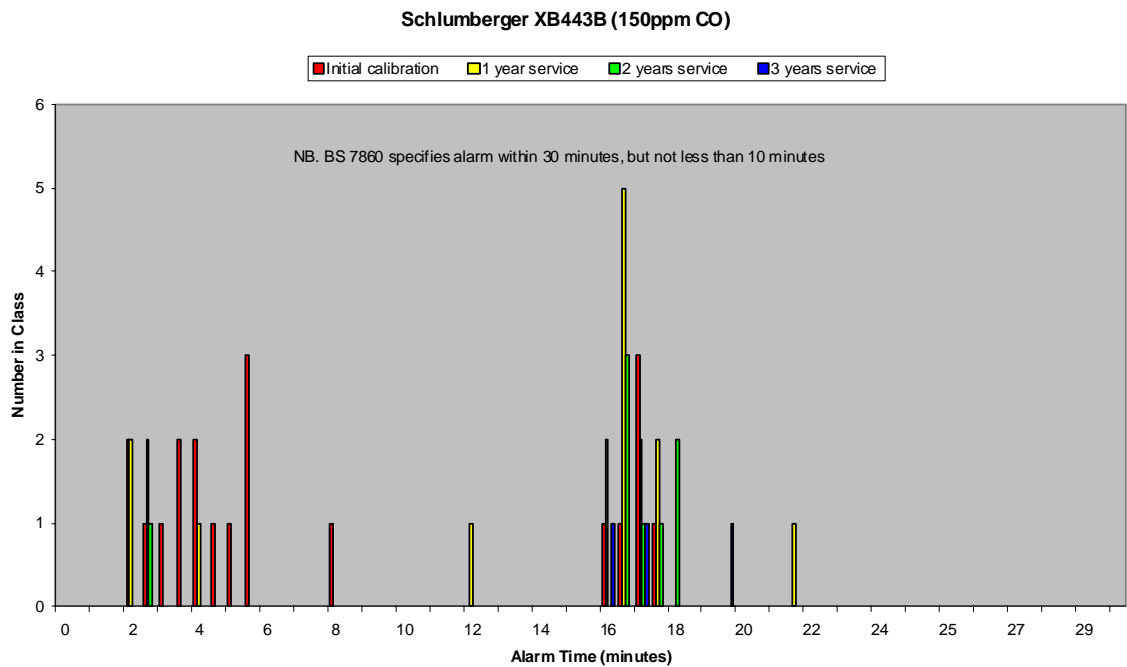
Figure 13. Schlumberger XH-443B Field Trial Results

- XH-443B: Figure 13 shows that significant variations have occurred in alarm performance over three years in service. This model was of interest because it utilised a newer type of semiconductor sensor, the New Cosmos CH-C. Even though the initial calibrations were slightly lower than specified by BS 7860, some specimens have experienced decreased sensor sensitivity by an excessive amount. Buzzer failures have also been noted, and five of the original twenty have now been withdrawn. The manufacturer has indicated that only a small number were sold, and the unit is no longer being supplied.

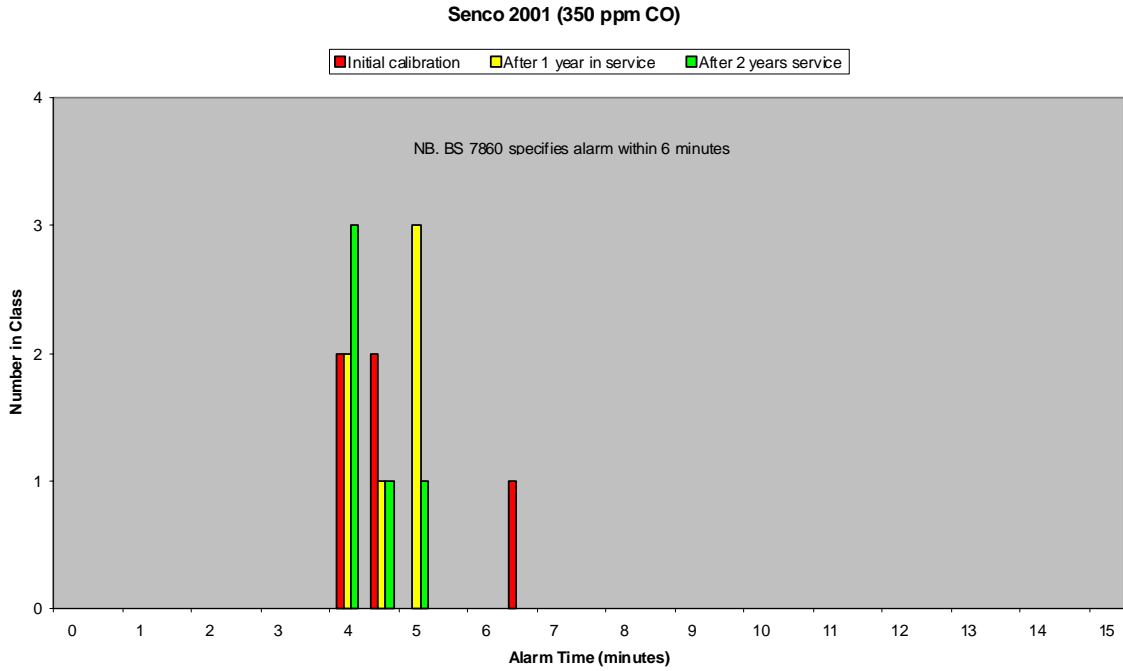
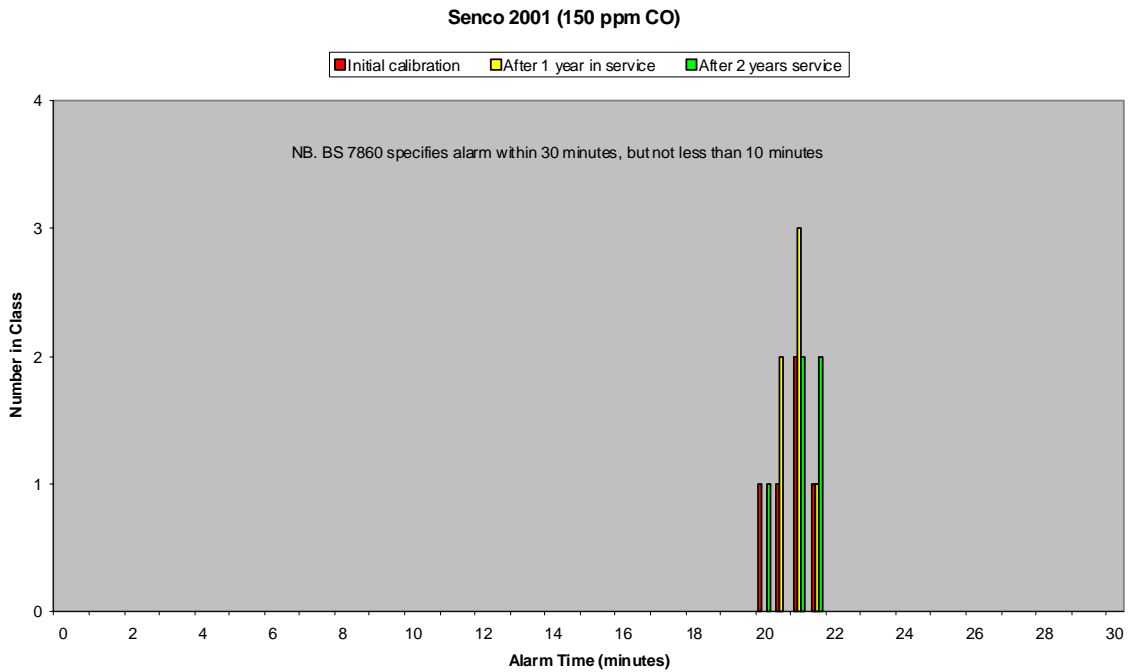
Figure 14. Senco 2001 Field Trial Results

- Model ONE (renamed as model 2001): A small batch has now been on field trial for 30 months, and Figure 14 shows that alarm performance is satisfactory so far. However, battery lifetime is only about two years, and faulty segments have appeared on the digital display of one of the units.
- Models 2002 and 2003: These are visually almost identical, and use the same sensor as the Senco model 2001. Only single specimens are therefore on field trial, and these are still performing satisfactorily after 1 year.

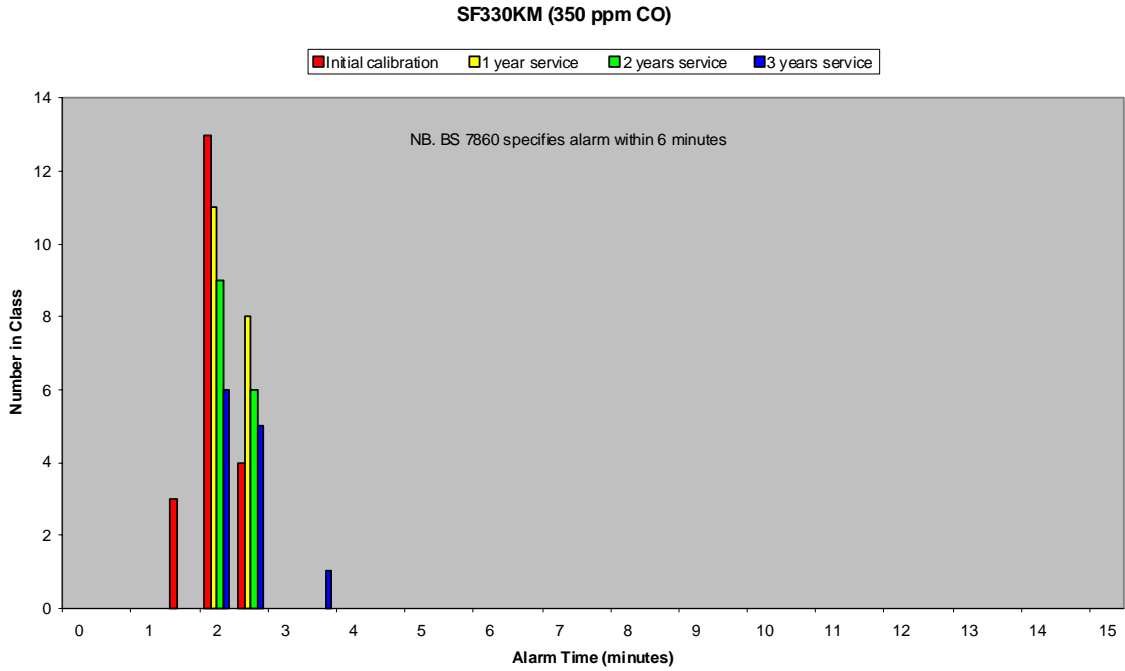
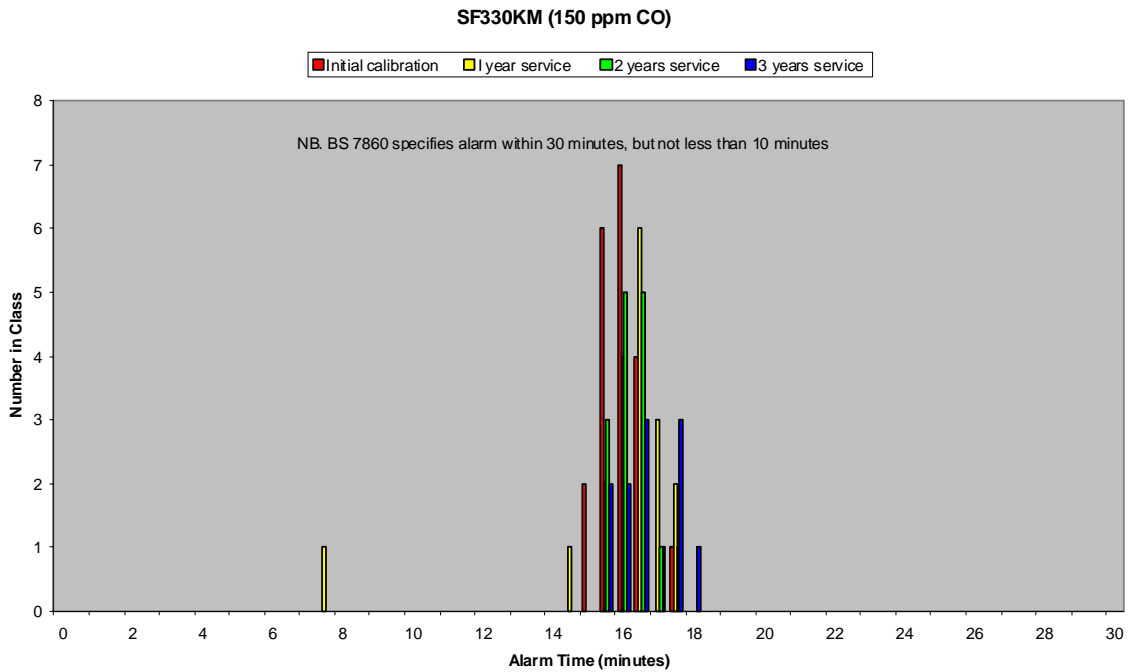
Figure 16. SF330KM Field Trial Results

- SF330KM: Figure 16 shows that alarm performance over 3 years has been good, with only small variations in sensor calibration. This model utilises the proprietary MIDI 40 electrochemical cell, which is now also incorporated into other makes and models. Some buzzer failures have been noted, although these may have been the result of physical mishandling. Failures of the non-replaceable battery have also occurred, and the larger test sample has enabled a more robust Weibull statistical analysis (see Reference 3) to be undertaken. This indicates a mean service battery lifetime of 4.5 years. This model constitutes a high proportion of the total UK population of domestic CO alarms actually installed in the UK, mainly because it was selected for use by Centrica (ie. British Gas Services) from 1997 onwards. It is estimated that at least one million such units have now been sold into the UK market.

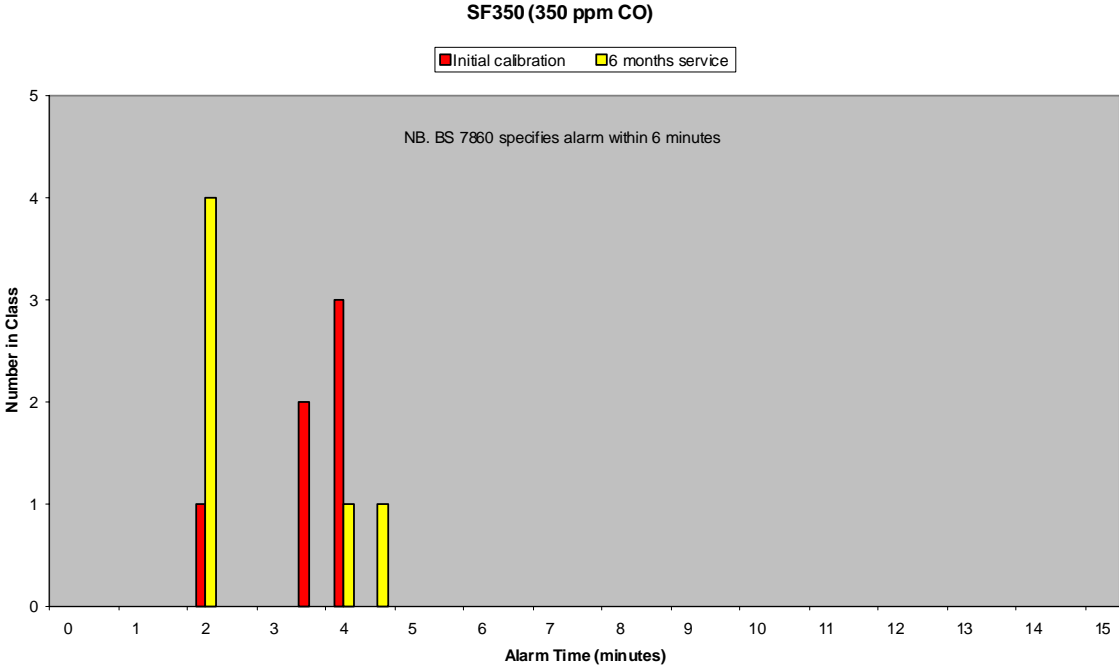
Figure 17. SF350 Field Trial Results

- SF350: This model, introduced by British Gas Services in 2000, utilises the same sensor as the SF330KM, and is expected to eventually replace that model in the UK market. It still uses a non-replaceable battery, but incorporates modifications aimed at improving battery lifetimes and buzzer reliability, as highlighted by the results of this project. Figure 17 shows satisfactory alarm performance for the small batch that has so far been on trial for six months.
